## Implementation report

# Bevaring, flytegro, Breisjøen 2020

Ref. 20SC991E

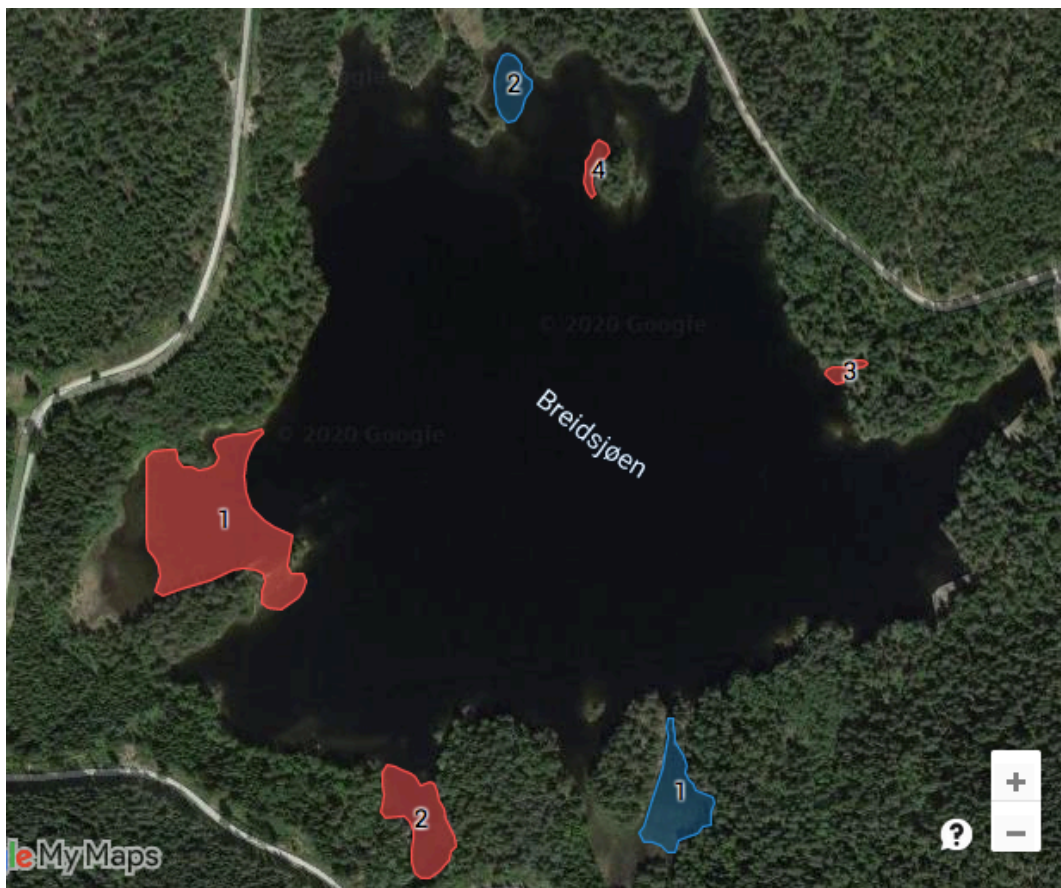
Map 1. Preliminary map of the distribution of areas intended for irrigation (red) and for flooding, construction of small dams (blue).

This project has been approved for implementation with the exception of area no 2 (red). The project aimed to protect the flytegro in different ways in different depth zones and habitats.

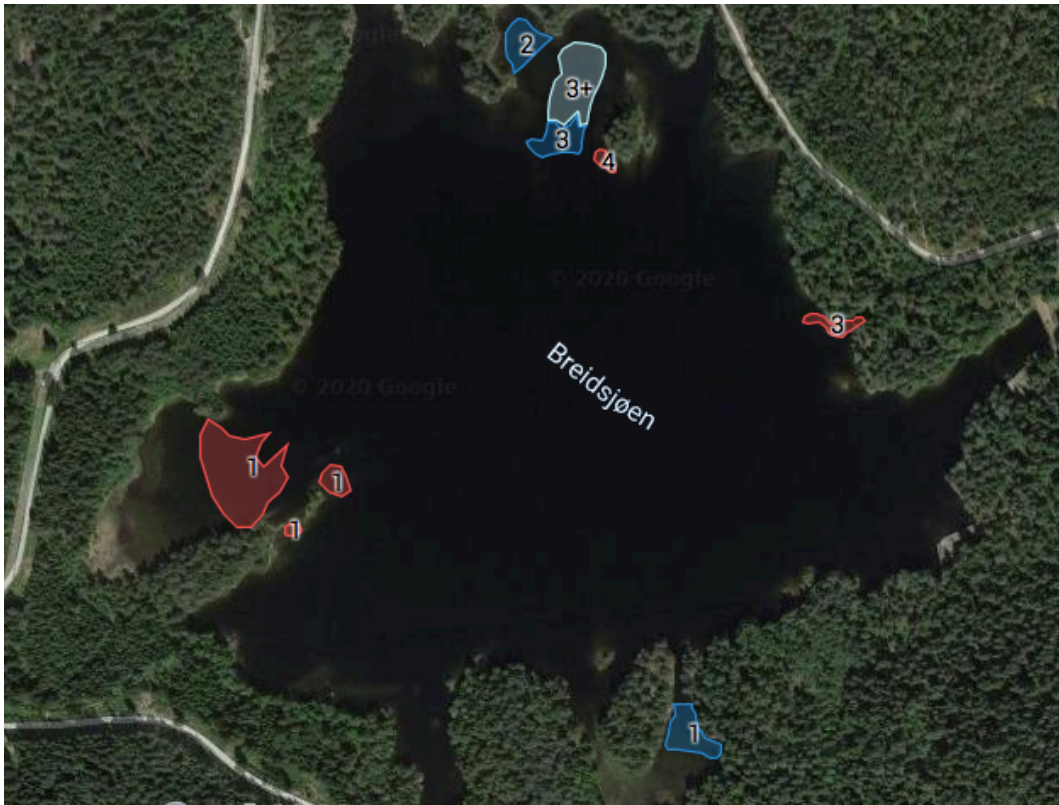
Map 2. Completed layout of irrigation areas and dams after border correction and construction of "our dam" no 3.

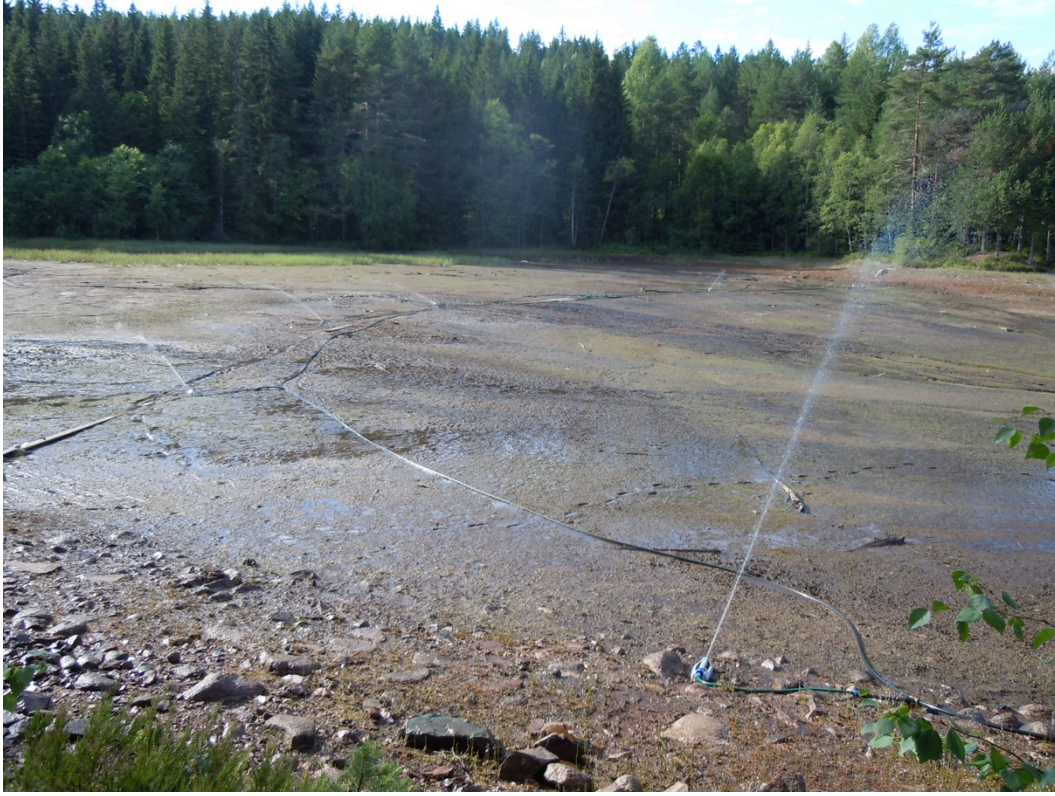
1. No 1 (red) Irrigation of the bay and peninsula in the Western part of the lake. This vast bay with a slightly sloping, silty bottom and abundant flytegro occurrence could ensure the survival of the plants if it could be kept wet or at least moist. An irrigation system was installed across the bay so that the sprinkled was a 20m wide strip and excess water flowed down below, moistening the rest of the exposed bay bottom. In this boggy bay, plank footbridges had to be built to provide access to the sprinklers. 3 sprinklers were placed higher on the peninsula to support plants in other habitats (at a depth of about 50 cm and 2 m from the normal water level) This system worked well - it allowed most of the plants on the irrigated surface to survive and grow as a terrestrial form. Some plants have been destroyed or damaged by grazing of the Canadian goose family and ducks. The system was dismantled on 10/21/2020 when most of the plants were already under water again.

Photo 1. No 1 (red) Irrigation on the western bay.

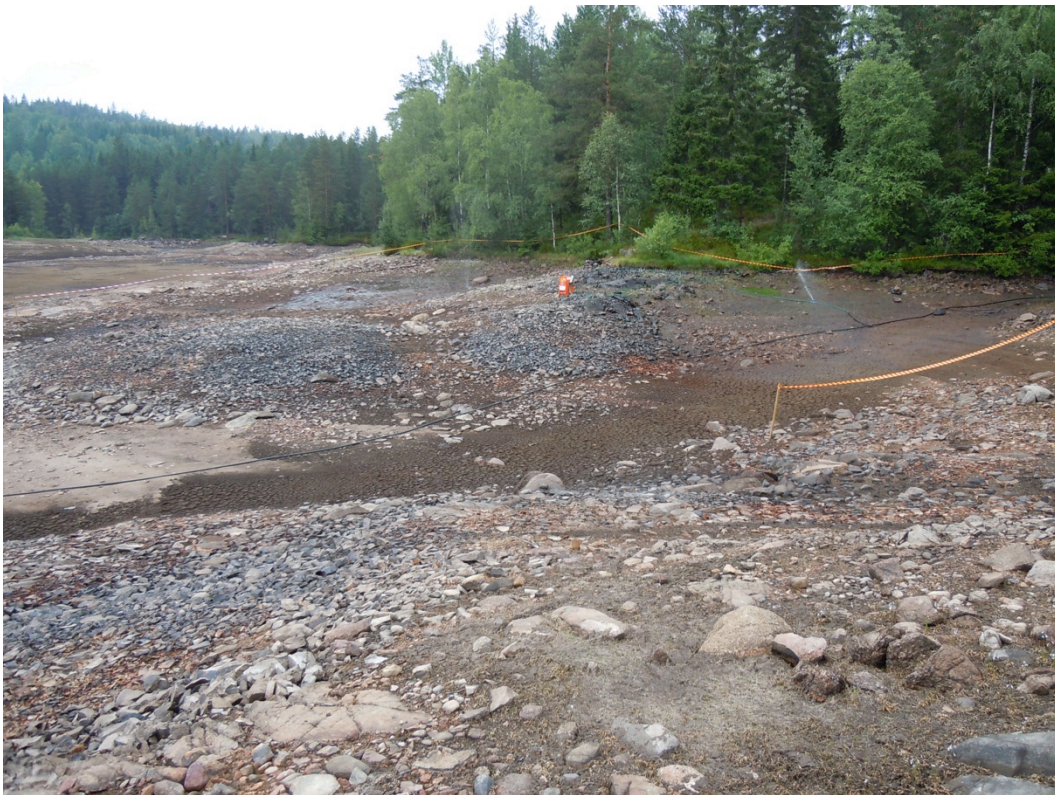
2. No 3 (red) Irrigation of the small bay and the slope of the bottom in the eastern part of the lake. Plants growing on the bottom slope with a small layer of clay and silt at a depth of 30 cm to 1.5 m were to be protected here. There are 3 sprinklers here.

At this place, it was necessary to make the tape fence due to the frequent visits of people and the trampling of the plants.

This system worked well - it allowed most of the plants on the irrigated surface to survive and grow as a terrestrial form.

Photo 2. No 3 (red) Irrigation of the small bay and the slope of the bottom in the eastern part of the lake.

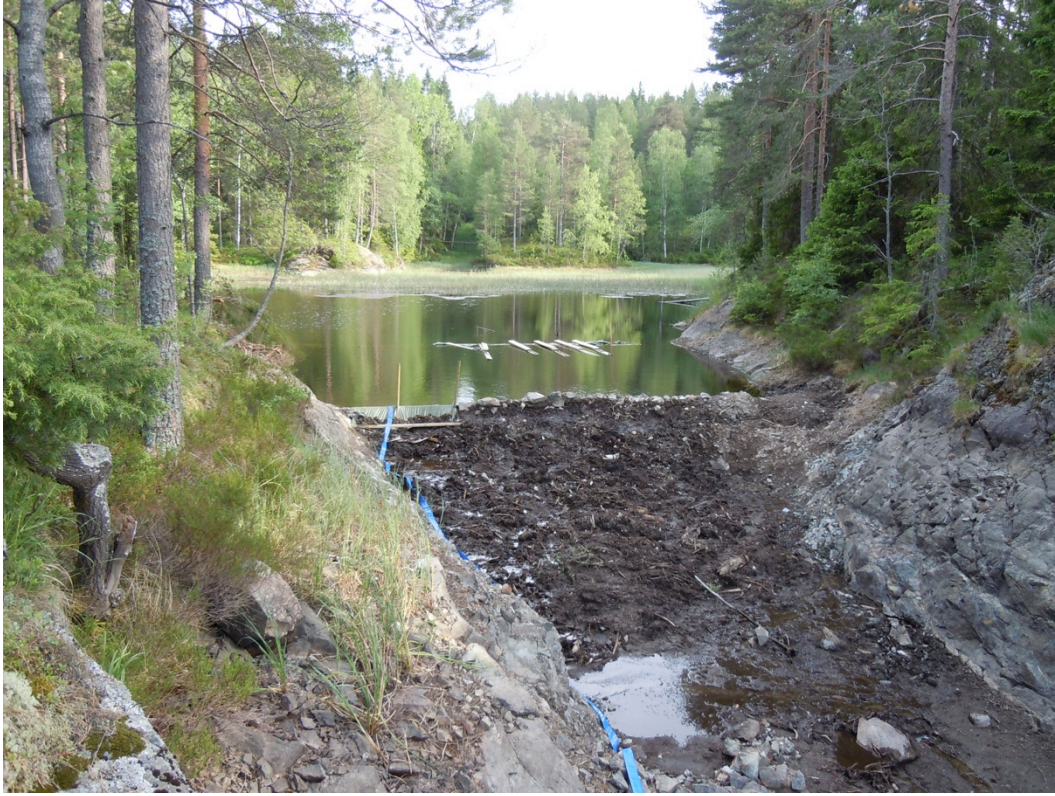
4. No 1 (blue) Dam in the southern part of the lake. This dam was supposed to keep the plants shallow (20 -30 cm deep) what should enable their survival and cause a strong development of floating leaves and flowers. This dam did not have the expected effect. Only the plants on the shores of the pond survived.

Photo 3. No 1 (blue) Dam in the southern part of the lake.

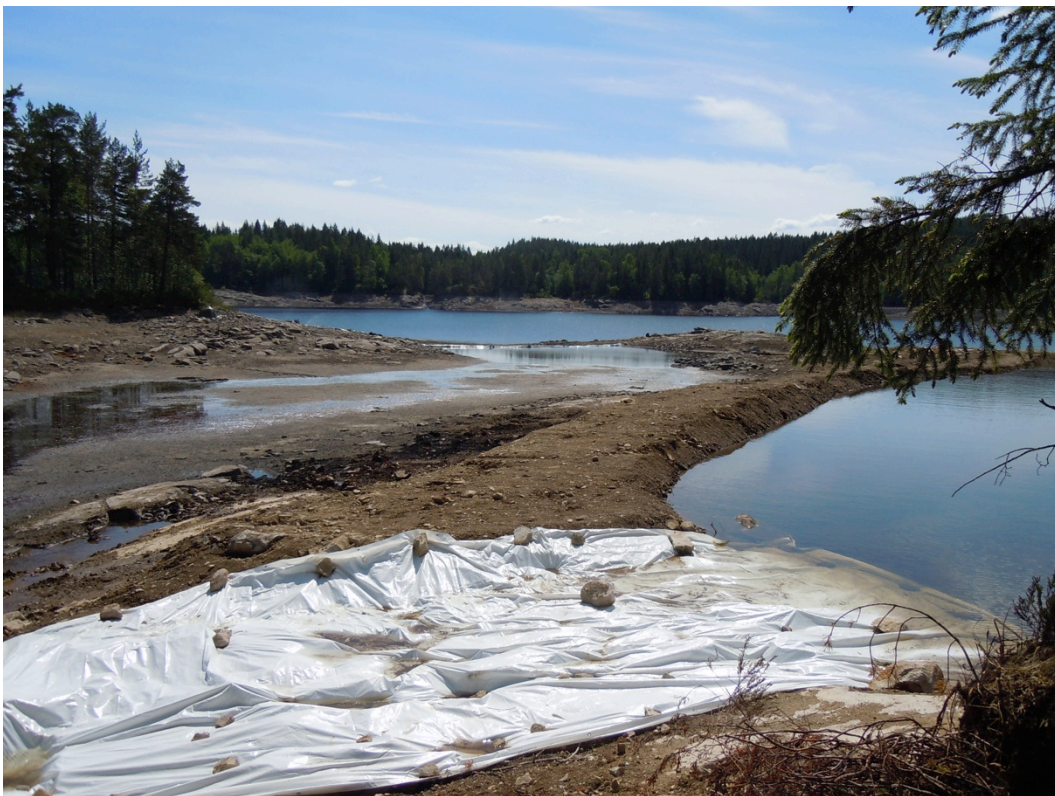
5. No 2 (blue) Dam in the northern part of the lake. This dam was to provide the plants with "normal" living conditions throughout the reduced water level in Breisjøen.

Dam no 2 with a water depth of up to 60 -80 cm enabled the plant to rebuild an underwater, vegetative rosette of leaves. "Our dam" no 3, with a depth of up to 20 -30cm allowed the lush growth of the form with floating leaves and flowers. The deliberately overflowing water from dam no. 2 irrigated the surface of a large flat area (no 3+) of the bottom above "our dam" contributing to a very lush growth of the flytegro terrestrial form, and sprinkling on the slope of the island (no 4 (red)) kept some plant alive in terrestrial form.

Unfortunately, this area suffered from bird feeding.

Some damage was done by the Canadian goose family in May and June, but the ducks feeding here at night did a great deal of damage already during the filling of Breisjøen in October. Almost 100% of plants with floating leaves and a large part of the terrestrial form were destroyed.

Photo 4. No 2 (blue) Dam (on right), “our dam” no 3 and wet area no 3+ (center), No 4 (red) Irrigation (left) in the northern part of the lake.
