Implementation report

Bevaring, flytegro, Breisjøen 2020

Ref. 20SC991E

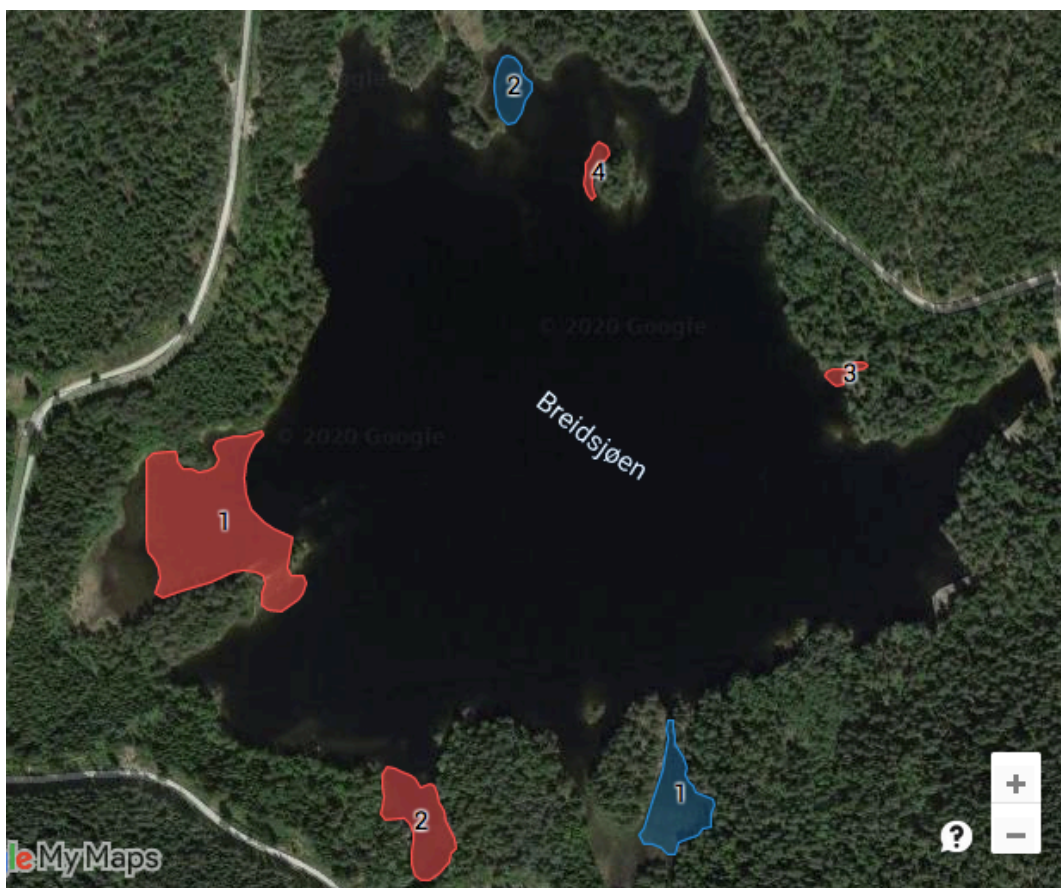
Map 1. Preliminary map of the distribution of areas intended for irrigation (red) and for flooding, construction of small dams (blue).

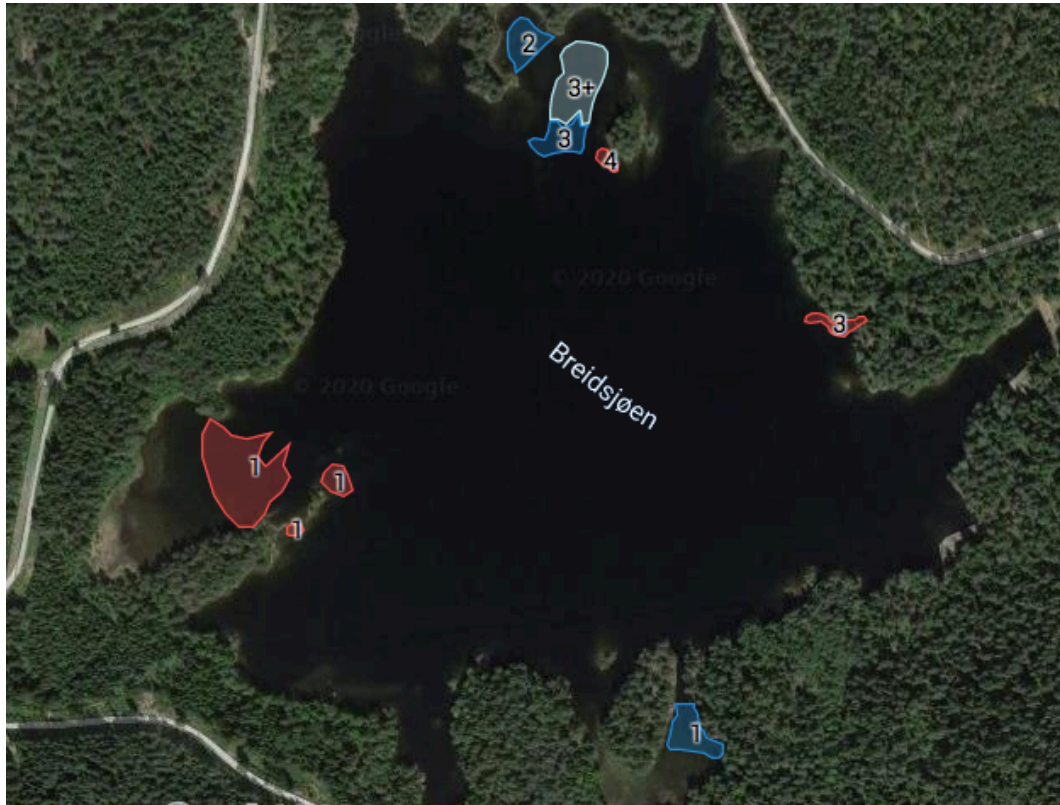
Map 2. Completed layout of irrigation areas and dams after border correction and construction of "our dam" no 3.

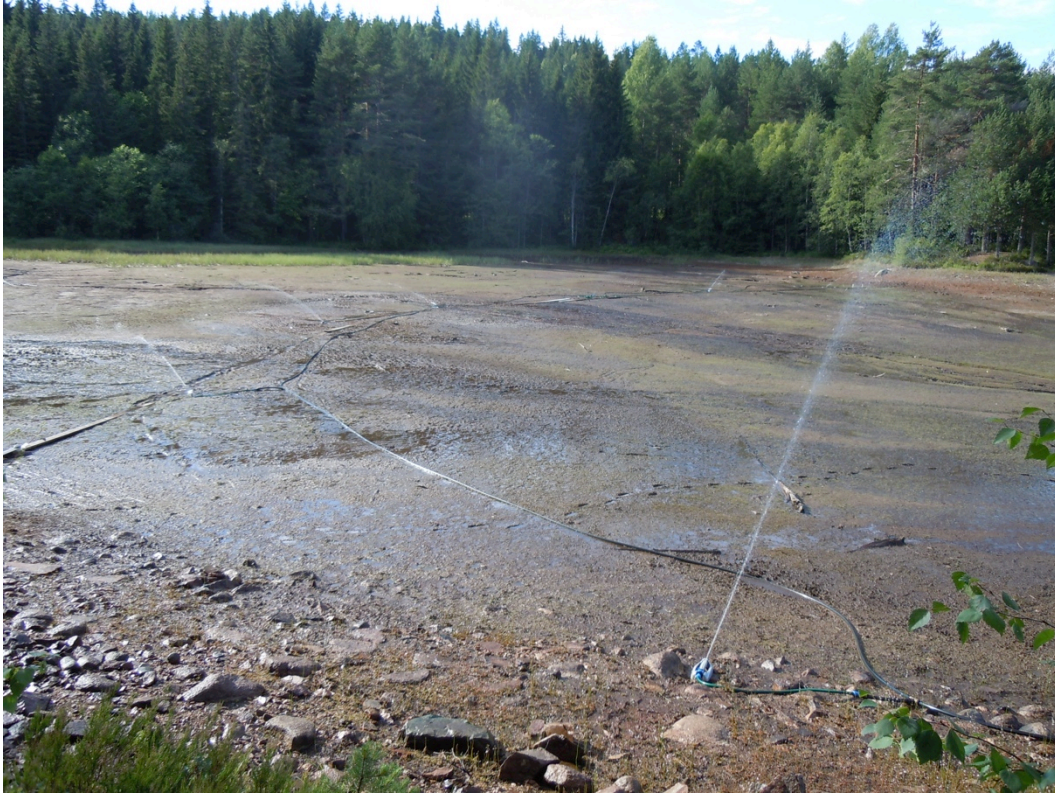
1. No 1 (red) Irrigation of the bay and peninsula in the Western part of the lake. This vast bay with a slightly sloping, silty bottom and abundant flytegro occurrence could ensure the survival of the plants if it could be kept wet or at least moist. An irrigation system was installed across the bay so that the sprinkled was a 20m wide strip and excess water flowed down below, moistening the rest of the exposed bay bottom. In this boggy bay, plank footbridges had to be built to provide access to the sprinklers. 3 sprinklers were placed higher on the peninsula to support plants in other habitats (at a depth of about 50 cm and 2 m from the normal water level) This system worked well - it allowed most of the plants on the irrigated surface to survive and grow as a terrestrial form. Some plants have been destroyed or damaged by grazing of the Canadian goose family and ducks. The system was dismantled on 10/21/2020 when most of the plants were already under water again.

Photo 1. No 1 (red) Irrigation on the western bay.

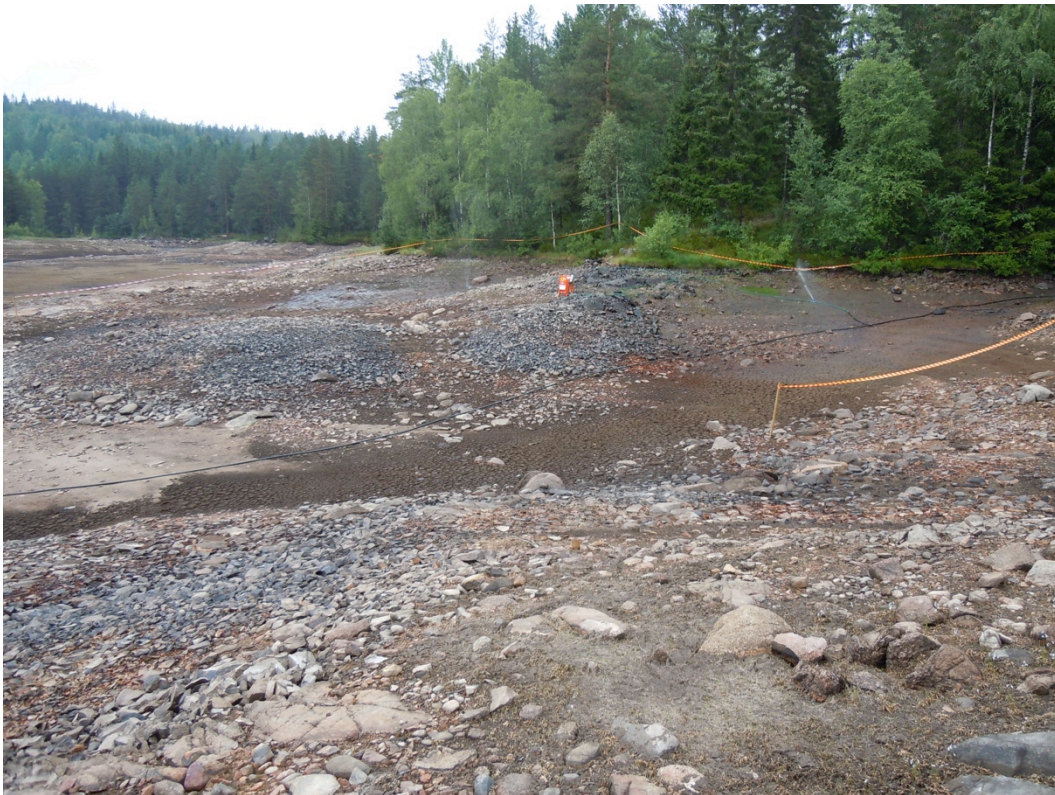
2. No 3 (red) Irrigation of the small bay and the slope of the bottom in the eastern part of the lake. Plants growing on the bottom slope with a small layer of clay and silt at a depth of 30 cm to 1.5 m were to be protected here. There are 3 sprinklers here.

At this place, it was necessary to make the tape fence due to the frequent visits of people and the trampling of the plants.

This system worked well - it allowed most of the plants on the irrigated surface to survive and grow as a terrestrial form.

Photo 2. No 3 (red) Irrigation of the small bay and the slope of the bottom in the eastern part of the lake.

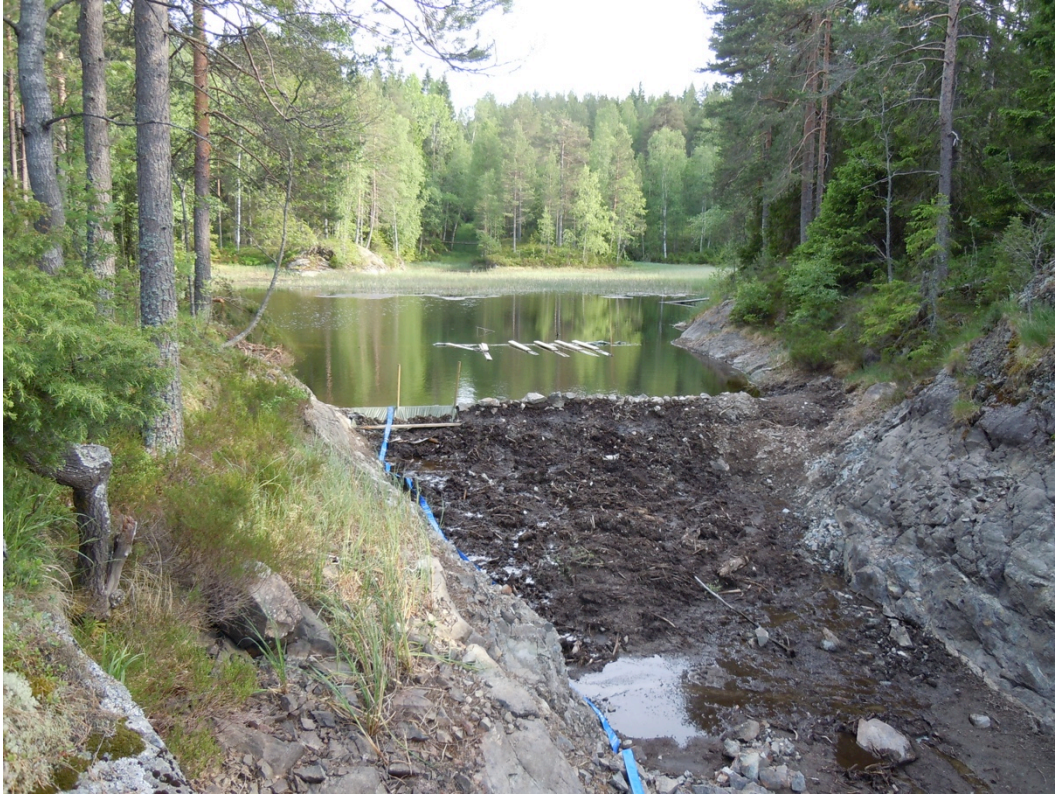
4. No 1 (blue) Dam in the southern part of the lake. This dam was supposed to keep the plants shallow (20 -30 cm deep) what should enable their survival and cause a strong development of floating leaves and flowers. This dam did not have the expected effect. Only the plants on the shores of the pond survived.

Photo 3. No 1 (blue) Dam in the southern part of the lake.

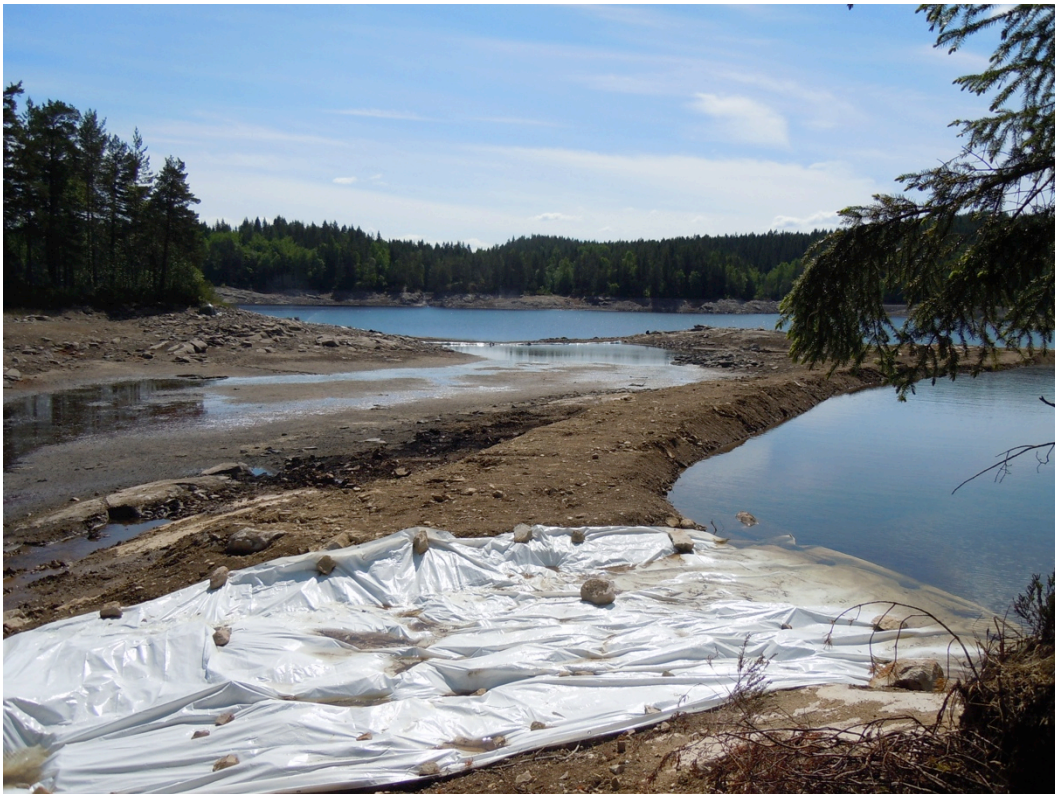
5. No 2 (blue) Dam in the northern part of the lake. This dam was to provide the plants with "normal" living conditions throughout the reduced water level in Breisjøen.

Dam no 2 with a water depth of up to 60 -80 cm enabled the plant to rebuild an underwater, vegetative rosette of leaves. "Our dam" no 3, with a depth of up to 20 -30cm allowed the lush growth of the form with floating leaves and flowers. The deliberately overflowing water from dam no. 2 irrigated the surface of a large flat area (no 3+) of the bottom above "our dam" contributing to a very lush growth of the flytegro terrestrial form, and sprinkling on the slope of the island (no 4 (red)) kept some plant alive in terrestrial form.

Unfortunately, this area suffered from bird feeding.

Some damage was done by the Canadian goose family in May and June, but the ducks feeding here at night did a great deal of damage already during the filling of Breisjøen in October. Almost 100% of plants with floating leaves and a large part of the terrestrial form were destroyed.

Photo 4. No 2 (blue) Dam (on right), “our dam” no 3 and wet area no 3+ (center), No 4 (red) Irrigation (left) in the northern part of the lake.
