Implementation report

Kartlegging og overvåking, flytegro Breisjøen 2020

20SD8D0A

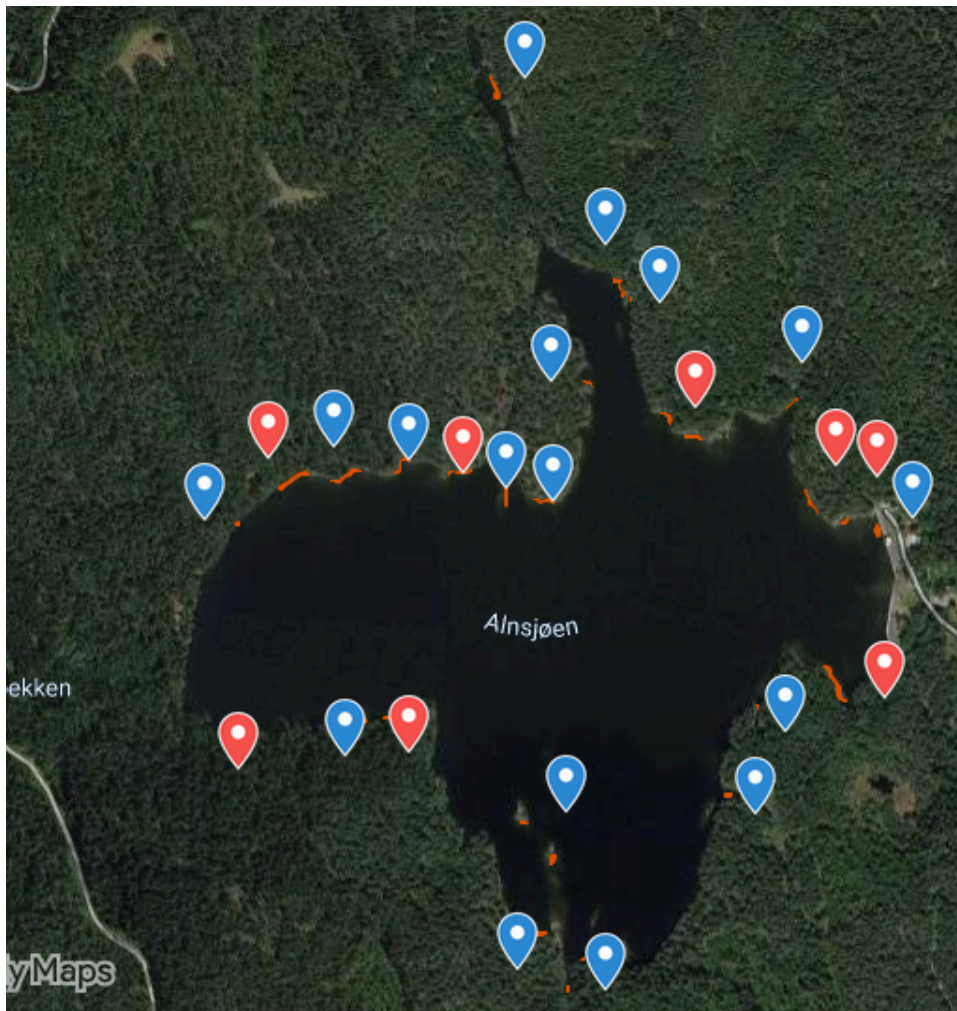
Map 1. Result of transplanting *Luronium* to Alunsjøen. As of August 1, 2020. The 2019 planting locations are marked in red. Places where the presence of *Luronium* has been confirmed in 2020 - red points. Blue points - not confirmed.

The result was not very impressive - for 25 planting places only in 8 of them I confirmed the presence of *Luronum* ... Map 1.

I expected a better result, but on the other hand, there is a certainty that at 8 sites, in different parts of the lake, *Luronium* has adopted and there is a chance that it will develop there.

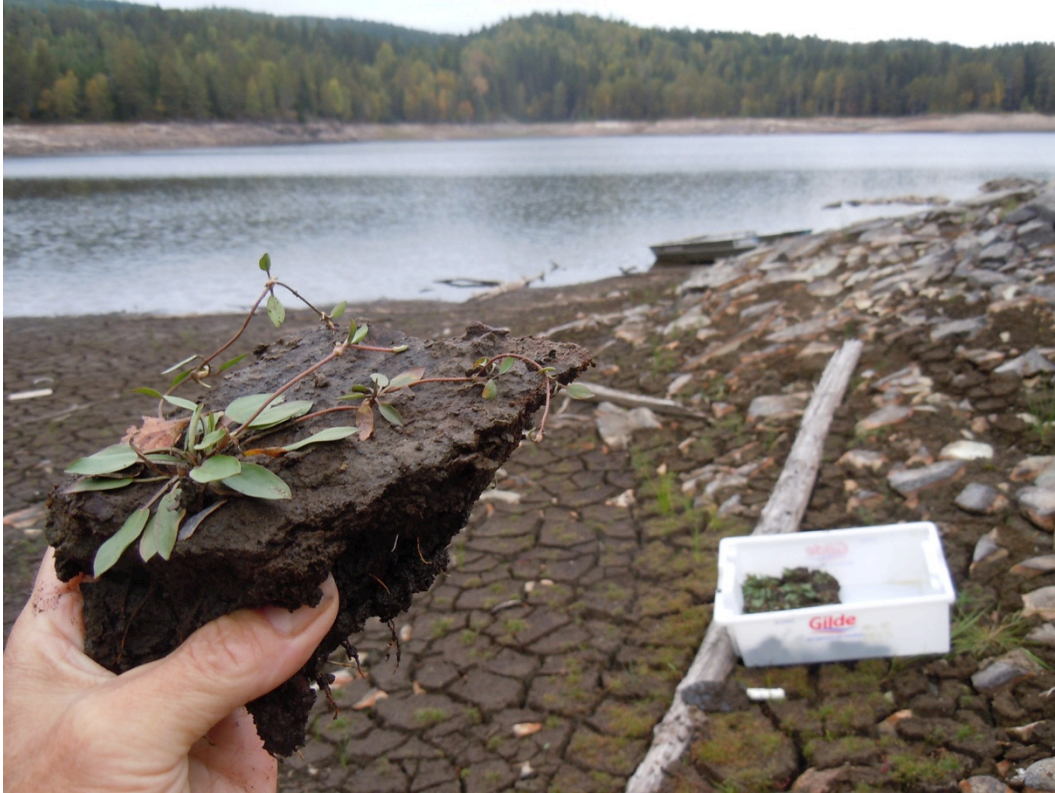
Photo 1. Well developed terrestrial form with stolons ready for replanting.

It seems that transplanting plants in a terrestrial form with a compact lump of the substrate gives better results than transplanting forms growing in water. (as was done last year).

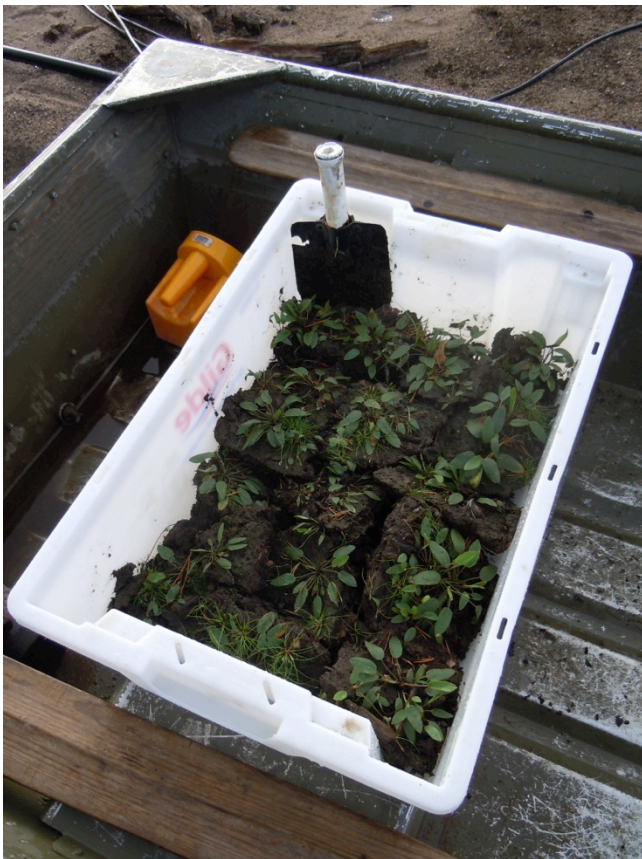
Photo 2. These plants were transplanted to Alunsjøen with good results.

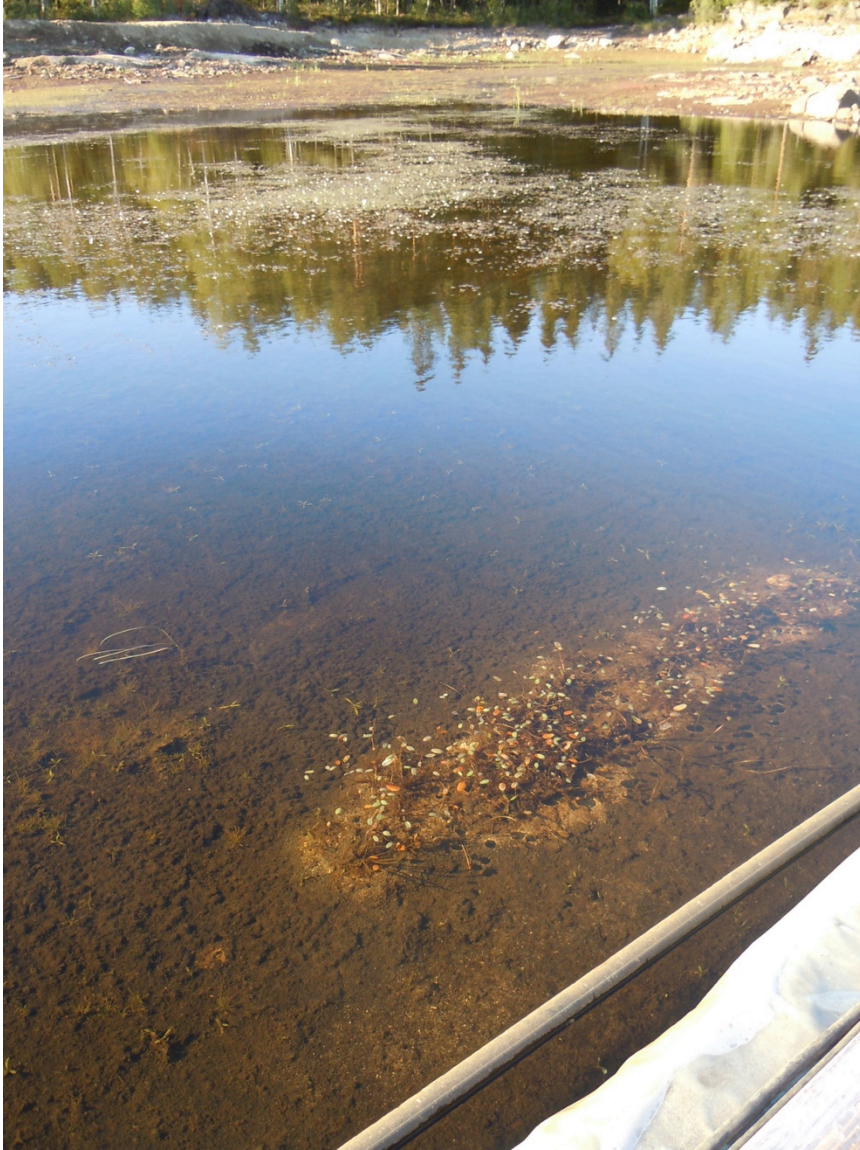
Photo 3. A terrestrial form with a compact lump of the substrate transplanted as a test to dam no 3. All plants survived and developed floating leaves.

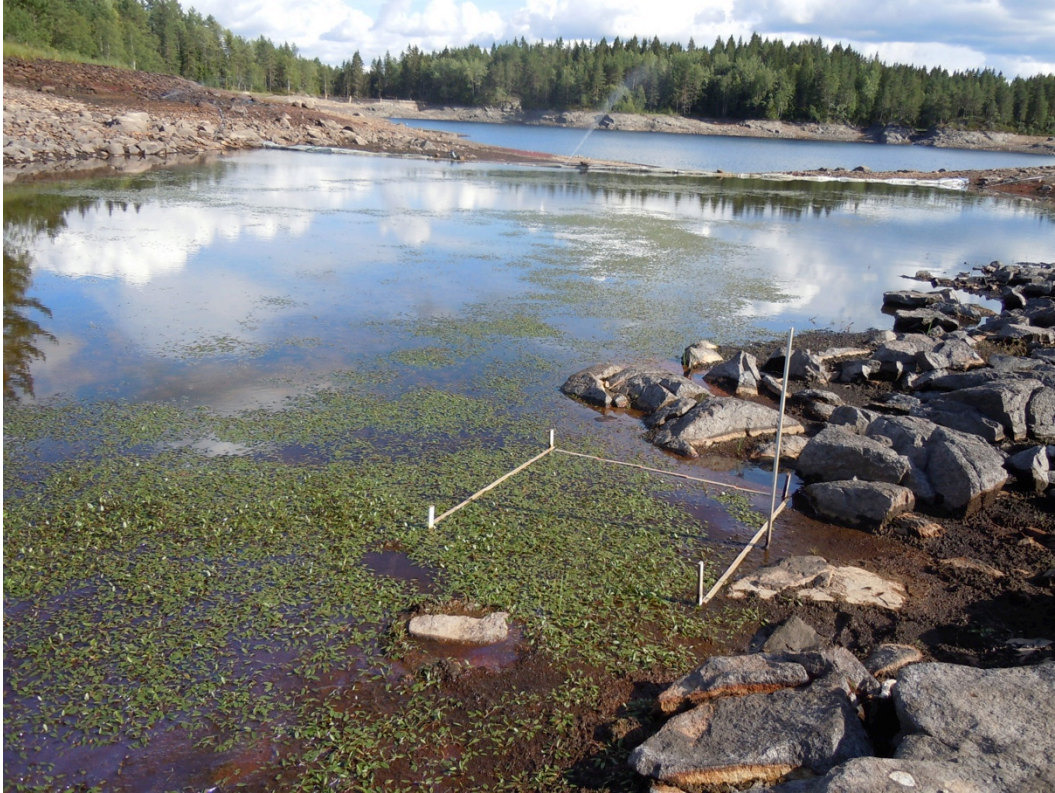
Photo 4. Dam no.3 with abundant growth of the terrestrial form of *Luronium* and the form with floating leaves. 25.07.2020.

In the dam no 3 with a depth of 20 - 30 cm, the plants formed floating leaves and bloomed profusely.

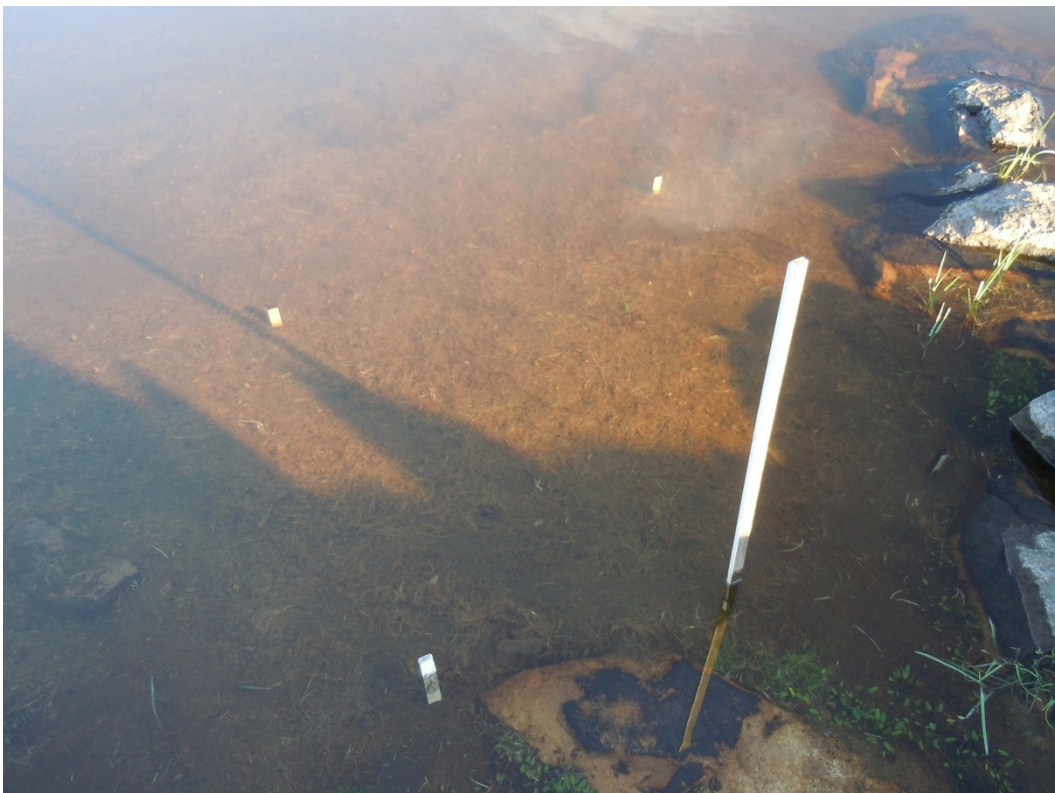
But the real tragedy was when the ducks were feeding at night in October while the lake was refilled. The ducks destroyed almost 100% of the plants from dam no. 3, a large part of the plants from the shallower places of dam no. 2 and a significant part of the plants growing as a land form.

Photo 5. Same area damaged (eaten) by ducks. 11.10.2020.
